## First Place — Restoration, Renovation & Expansion: Sprunk residence

**Location:** Seattle

**Mason contractor:** Rife Masonry

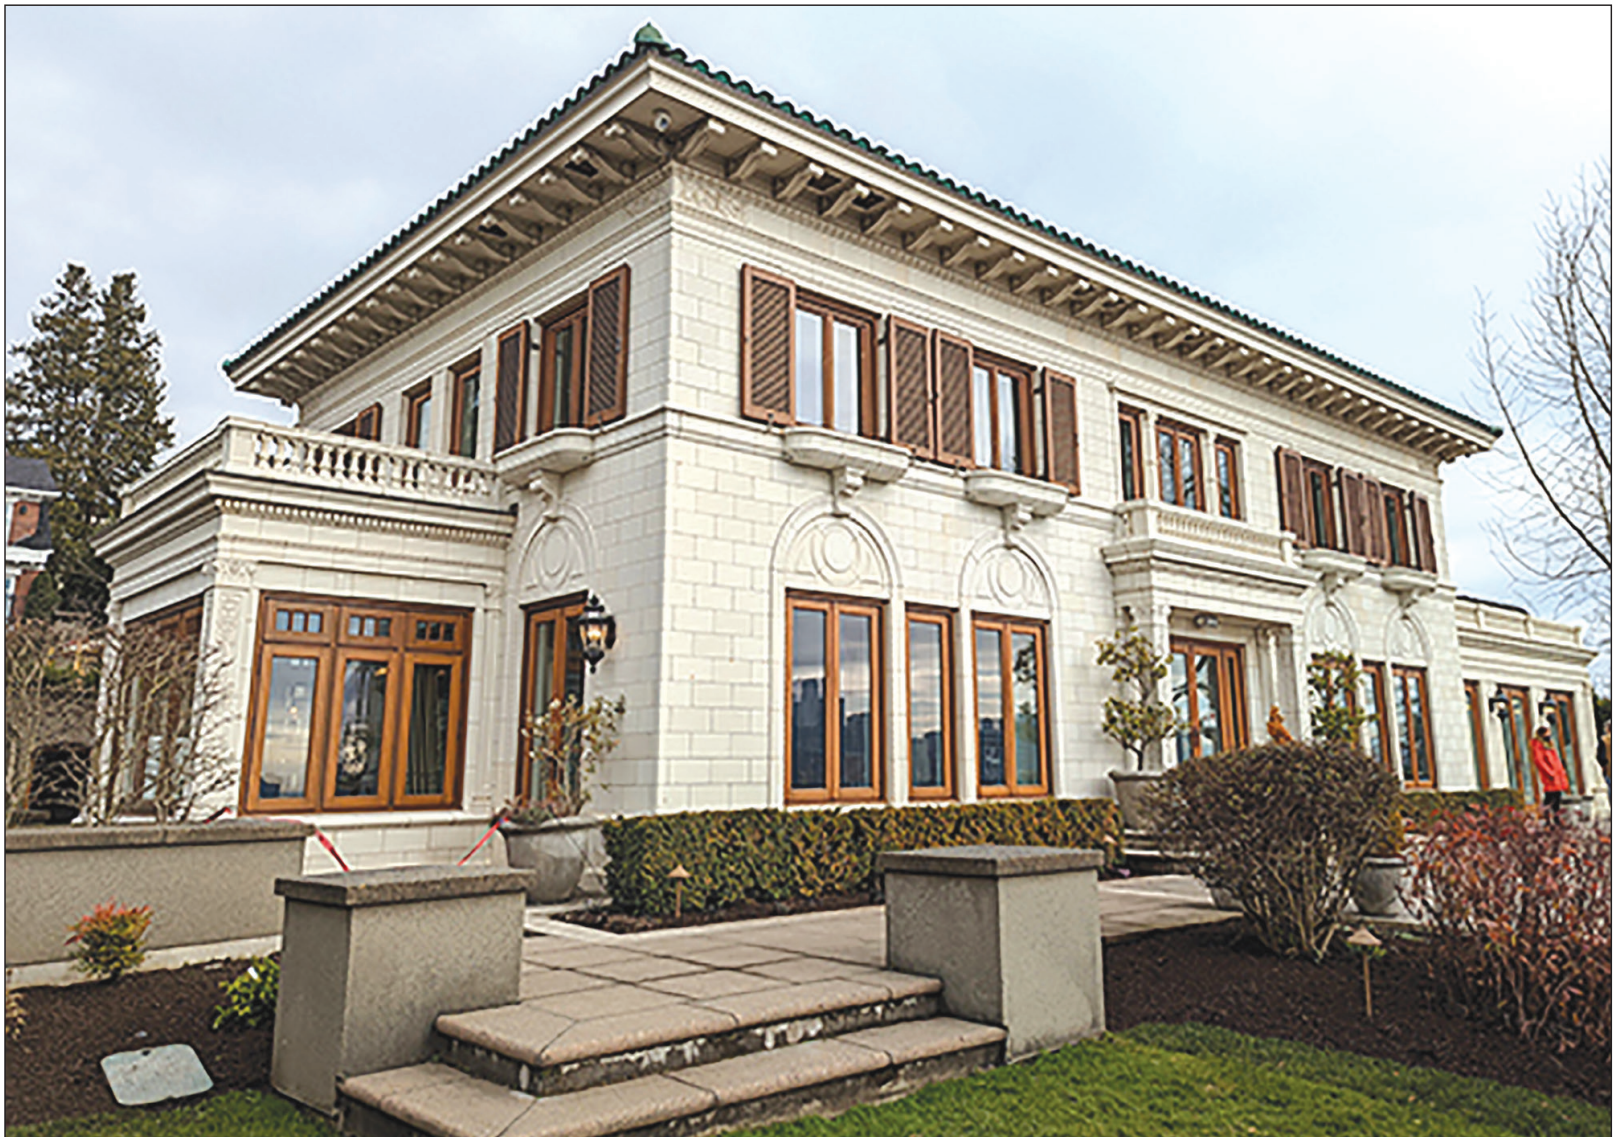
The Sprunk residence's exterior is constructed of terra-cotta, mortar and all the proper building materials to make this house stand the test of time.

Crews first pressure-washed the south elevation with hot water and Prosoco 2010 all-surface cleaner. Then, all the terra-cotta on two corners of the south elevation was removed, labeled and set aside for repairs.

The repair process consisted of installing stainless-steel washers and all thread rod for reinforcement — epoxied in place to add strength to the terra-cotta. The next step was to install Conproco Matrix patching material, and Conproco Matrix TR to the thin spalls and cracks. Conproco TerraColor was the product of choice to color match the patches to the existing building.

Finally, the repaired terra-cotta was ready to get installed. With this process, Rife Masonry fabricated 2-inch stainless steel clips to fasten to the existing retrofit grid.

All the corner terra-cotta was installed, and a caulk sanded expansion joint would allow for movement in the future and not damage any of the historical elements of the residence. Dow Corning 795 with a clean washed sand was used to achieve a seamless appearance to match the mortar as well.
